4.1.5 Traffic and Pedestrian Rails

4.2 Superstructure

5 Summary and Conclusions

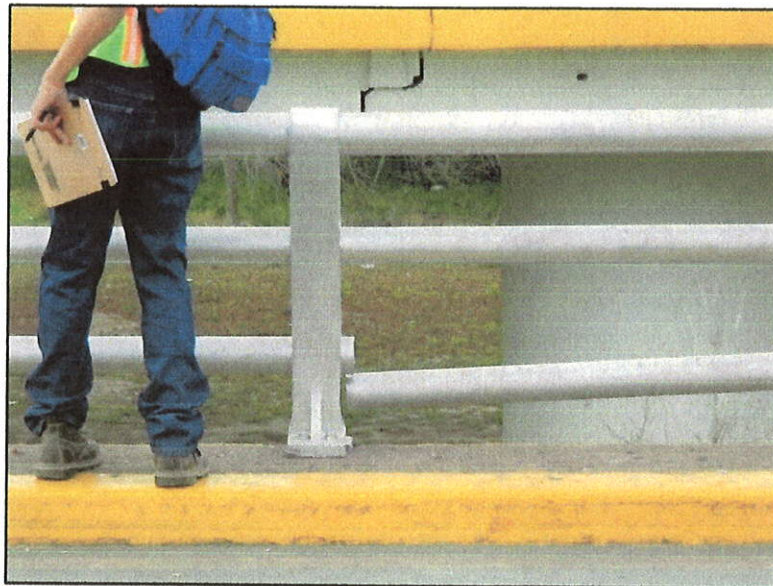
Figure 4.1.5-A (Mexico)

The traffic rail that runs along the west edge of the roadway has minimal damage and a major constructability issue. A part of the bottom of the rail is detached from the vertical support (See Figure 4.1.5–A). There are no issues with the rail alignment that warrant discussion. There are many locations where the anchor bolt nuts are not properly tightened to the top of the rail connection

plate or are missing altogether. Figure 4.1.5-B shows an example of this. There is minimal spalling present on top of the curb where rail is bolted in (See Figure 4.1.5-C). This traffic rail requires immediate action with the proper placement of anchor bolts and nuts to the connection plates. Overall it appears to be in fair to satisfactory condition.

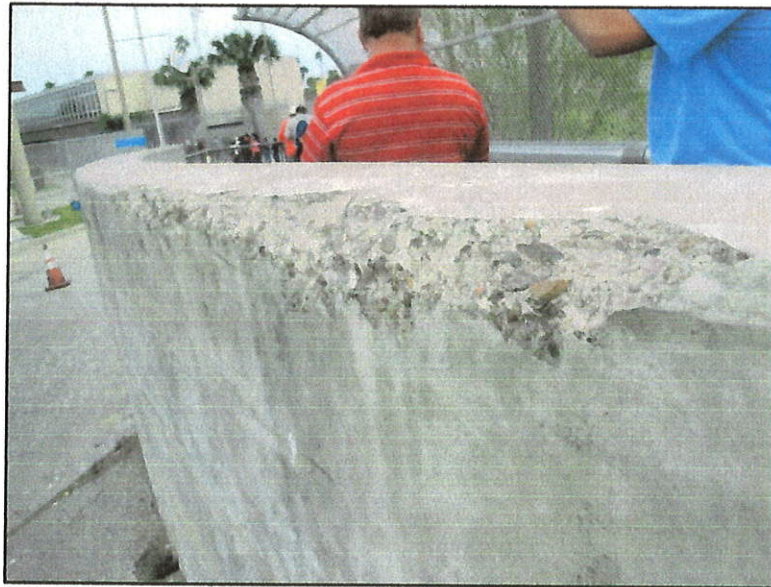
Figure 4.1.5–F (U.S.)

The pedestrian combination rail (PCR) that runs along the east edge of the roadway has minor honeycombing and transverse cracking throughout. The alignment of PCR is good and no major damage was noted. All post connections at the top of the rail are satisfactory along with the paint of both the concrete and steel. Figure 4.1.5-D shows a broad view of the PCR at the border. The U.S. side of the rail is to the left while the Mexico side is to the right. The PCR transitions to a combination rail without openings at span 5 (See Figure 4.1.5-E) and then transitions again into a tall concrete wall. There is some spalling noted at the top of this wall (See Figure 4.1.5-F). Overall the PCR and concrete wall appear to be in satisfactory condition.

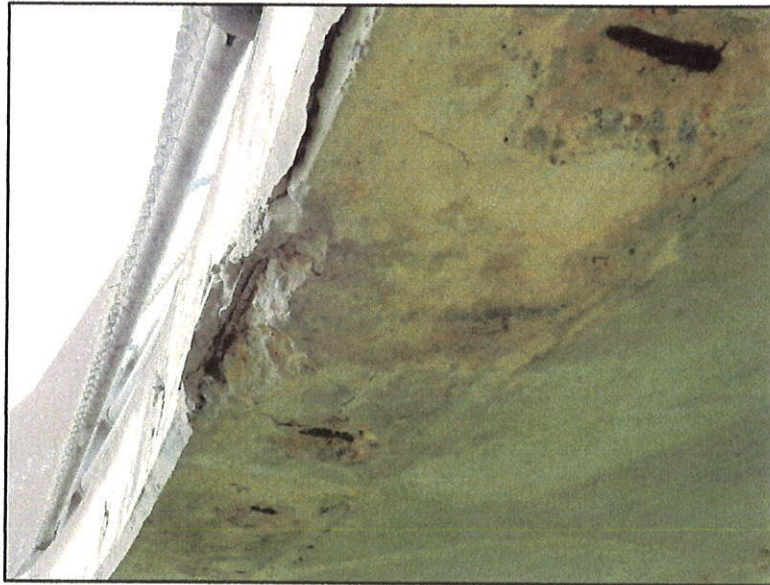
Figure 4.2.1-A (U.S.)

The overhang on the downstream side of span 5 near abutment 6 has exposed rebar and spalling concrete on the bottom of the overhang as shown in Figure 4.2.1-A. This is an extreme case of this general condition that exists at many locations along the overhang. The overhang edge also has spots where the concrete is delaminated as shown in Figure 4.2.1-B.

The deterioration on the overhangs is primarily in the narrow cast-in-place sections that run along the edges of the overhangs outside of the adjacent exterior T-beams for the entire length of the bridge.

The condition of spalled and delaminated concrete and exposed rebar, although it appears extensive in that it occurs in many areas throughout the bridge, is considered minor deterioration at this time because it occurs primarily, though not exclusively, in the overhangs. The overhangs are generally in fair to poor condition, and should be repaired soon, but they do not significantly affect the structural capacity of the bridge at this time.

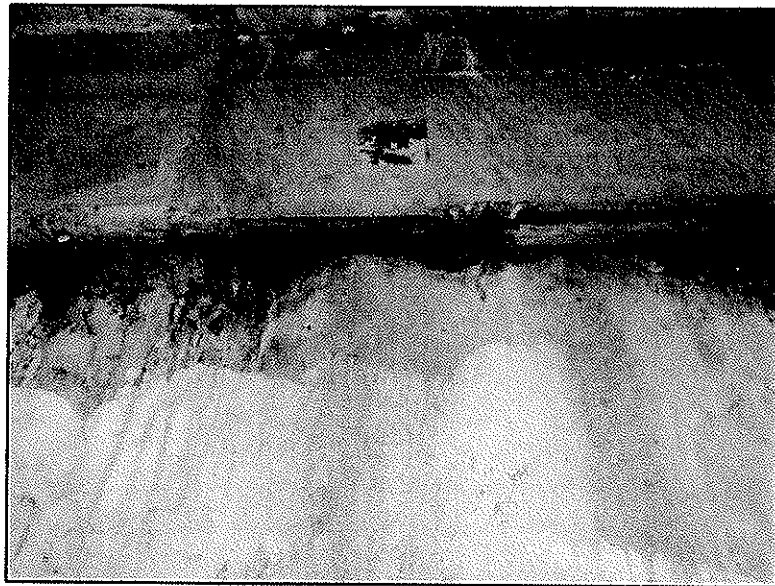
Figure 4.2.1-C (Mexico)

Some of the interior diaphragms have exposed rebar on the bottoms of the diaphragms. Many of the diaphragms on the Mexican side of the bridge have small patches where it appears minor repairs were made. At abutment 1 the bottom of the end diaphragm has exposed and rusty rebar as shown in Figure 4.2.1-C. Overall, the diaphragms are in satisfactory condition.

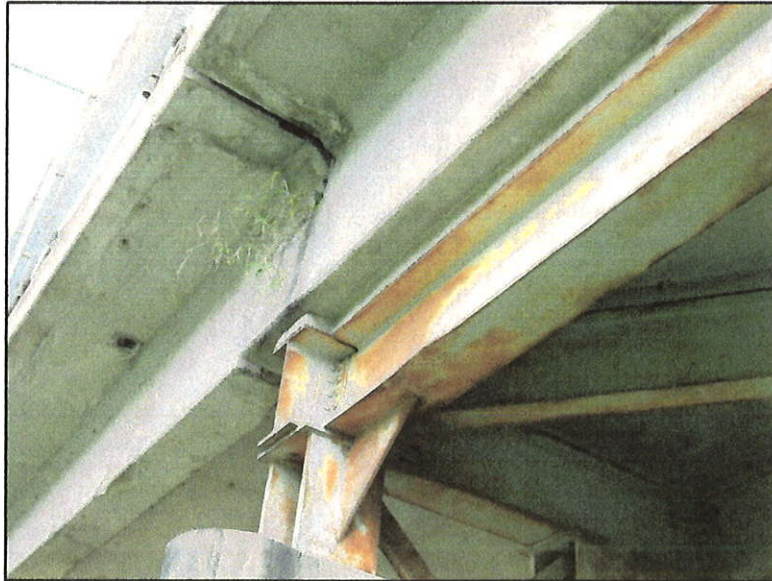
Figure 4.2.1-D (U.S.)

At the joint between the span 5 slab unit and bent cap 5 the edge of the slab overhang and bent cap overhang are offset. It is our understanding that this offset is due to movement of bent cap 5 that lead to the major repair of this bent cap. Figure 4.2.1-D above shows a close up of this condition where the edge of bent cap 5 is not in line with the edge of the overhang on the span 5 slab unit.

This condition does not significantly affect the structural capacity of the bridge at this time but warrants close monitoring.

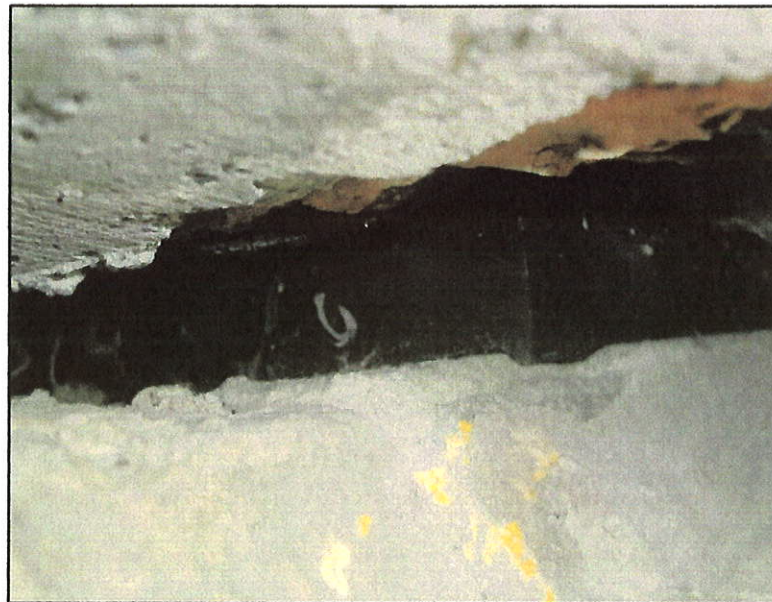
Figure 4.3.1-A (Mexico)

Observation of the bearing seats and bearing pads was constrained to the abutments since no overhead equipment was provided. The confined spaces made bearing seat and pad observations difficult at the abutments. Figure 4.3.1-A shows one of the bearing pads at abutment 1 that appears to be in good condition. Overall, observation of the bearing areas did not reveal any problems with the bearing seats and bearing pads which appear to be in satisfactory structural condition.

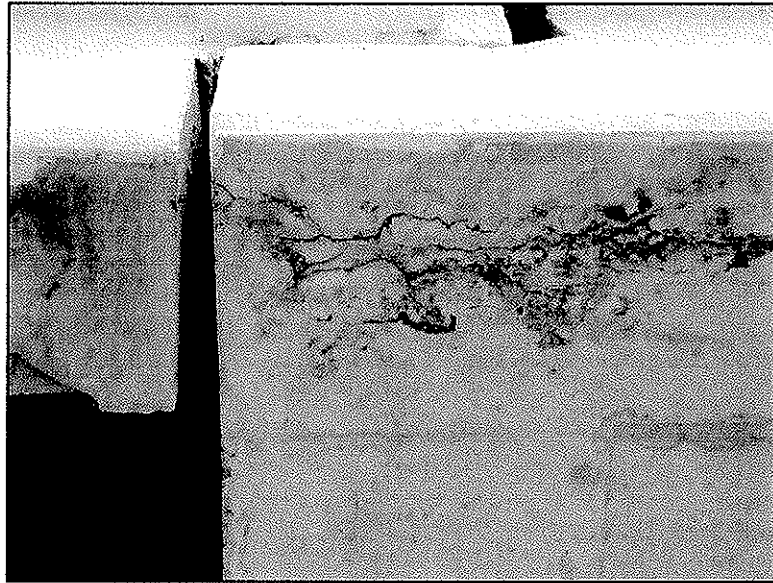
Figure 4.3.2-A (Mexico)

The bottom of the exterior cast-in-place overhang strip on the upstream side of bent cap 4 appears to have very little or no concrete cover. The bottom of bent cap 2 at the downstream side corner adjacent to span 1 is cracked and shows evidence of delamination as shown in Figure 4.3.2-A. On the Mexican side of the bridge, some of the bent caps have small patches on the bottom where it appears repairs were made. Also on the Mexican side, bent cap 2 has hardware embedded and left in place at the bottom of the cap from what appears to be epoxy injection repairs. Figure 4.3.2-B shows three locations of exposed rebar at the bottom of one of the bent caps on the Mexican side of the bridge.

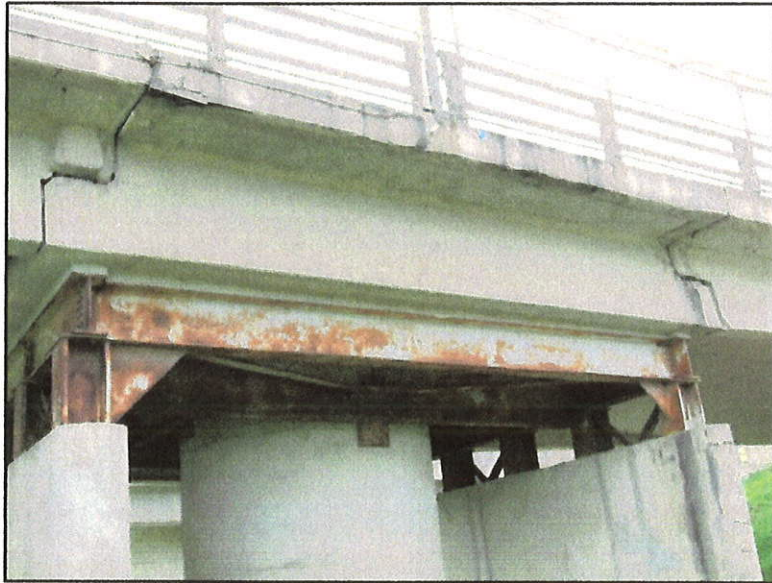
Figure 4.3.3-A (U.S.)

As mentioned in the previous section, bent cap 5 on the U.S. side is supported by a retrofitted steel frame and steel columns encased in concrete. Figure 4.3.3-A shows the bent 5 column and the steel repair structure. The steel frame is connected to the column and is supported by steel columns encased in concrete under the north and south ends of the bent cap. The repair steel structure

appears to be adequately supporting bent cap 5. The paint system on the steel frame and columns is failing and all the steel needs to be sanded and repainted. The north concrete encasement wall has exposed rebar on the downstream side. Soundings on the encasement walls indicate signs of delamination in several areas of the walls. The bent 5 column has a crack on the downstream side.
