4.1.5 Traffic and Pedestrian Rails

4.2 Superstructure

5 Summary and Conclusions

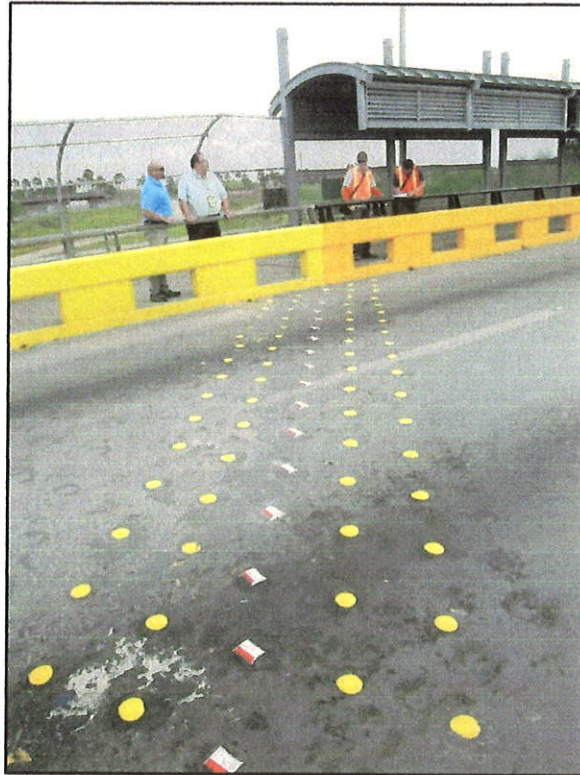
Figure 4.1.5-D (Mexico & U.S.)

The pedestrian combination rail (PCR) that runs along the east edge of the roadway has minor honeycombing and transverse cracking throughout. The alignment of PCR is good and no major damage was noted. All post connections at the top of the rail are satisfactory along with the paint of both the concrete and steel. Figure 4.1.5-D shows a broad view of the PCR at the border. The U.S. side of the rail is to the left while the Mexico side is to the right. The PCR transitions to a combination rail without openings at span 5 (See Figure 4.1.5-E) and then transitions again into a tall concrete wall. There is some spalling noted at the top of this wall (See Figure 4.1.5-F). Overall the PCR and concrete wall appear to be in satisfactory condition.

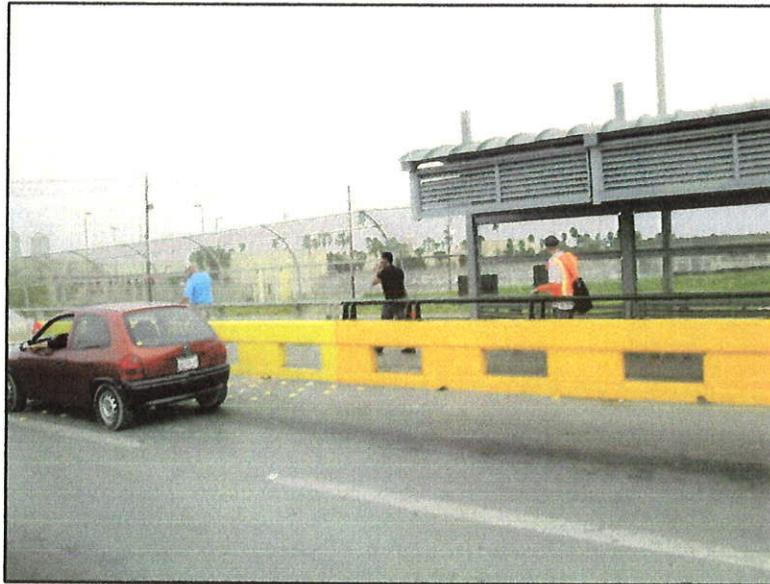
Figure 4.1.6–A (Mexico & U.S.)

The canopy (Mexico side) and high fence (U.S. side) both appear to be structurally adequate. Amongst the damage noted include damaged fencing, damaged bottom panels, and minor concrete spalling around the bolted connections to the sidewalk. There are also areas where the fencing panels are loose or not re-attached properly. The traffic rail behind the canopy and high fence appears to be in great condition since it has minimal exposure to pedestrians and traffic. There is not any notable damage to high fence on the U.S. side of the bridge. Figure 4.1.6–A shows the canopy on the right and the high fence on the left. This marks the border line for the U.S. and Mexico. Figure 4.1.6–B illustrates the typical damage to the bottom panels of the canopy. Figure 4.1.6–C shows a piece of the canopy fencing that needs to be re-attached properly while Figure 4.1.6–D shows a piece of canopy fencing that warrants replacement. Overall the canopy and high fence appear to be in good condition.

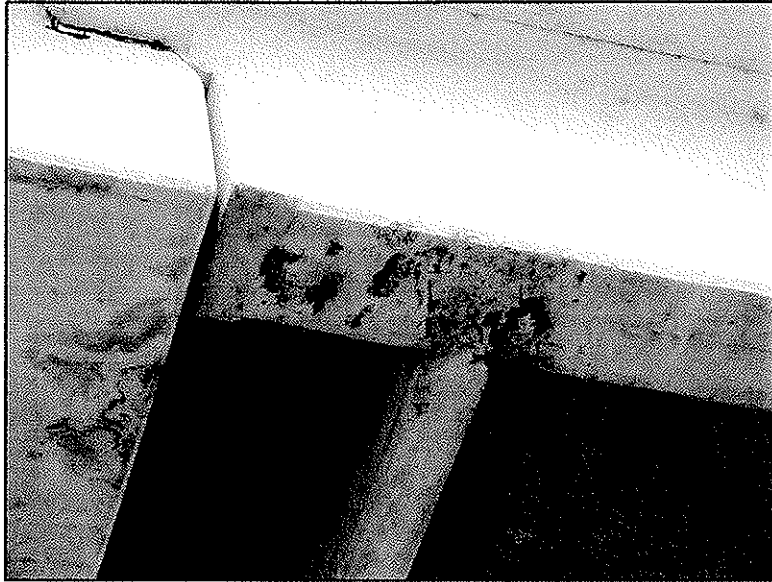
Figure 4.2.2-A (Mexico)

The bridge spans consist of T-beam spans from span 1 through span 4 and a slab span with exterior beams in span 5. On the Mexican side of the bridge the bottoms of the beams have many small patches where it appears that exposed rebar or other deterioration may have been patched and repaired. At span 3 the bottom of a beam has exposed rebar. An exterior beam on the Mexican side of the bridge has exposed rebar and honeycombing at the bottom of the beam near a bent cap as shown in Figure 4.2.2-A. Pieces of wood formwork are attached to the end of one of the beams on the Mexican side of the bridge. At span 5 one of the exterior beams on the upstream side of the bridge has some exposed rebar and spalling at the bottom of the beam as shown in Figure 4.2.2-B. The exposed rebar is minor deterioration and does not significantly affect the structural capacity of the bridge. Observation of the bearing pads and bearing seat areas was limited to the abutments where observation was still limited due to the confined space. However, observation of the bearing areas did not reveal any problems with the beams. Overall the beams are in good structural condition.

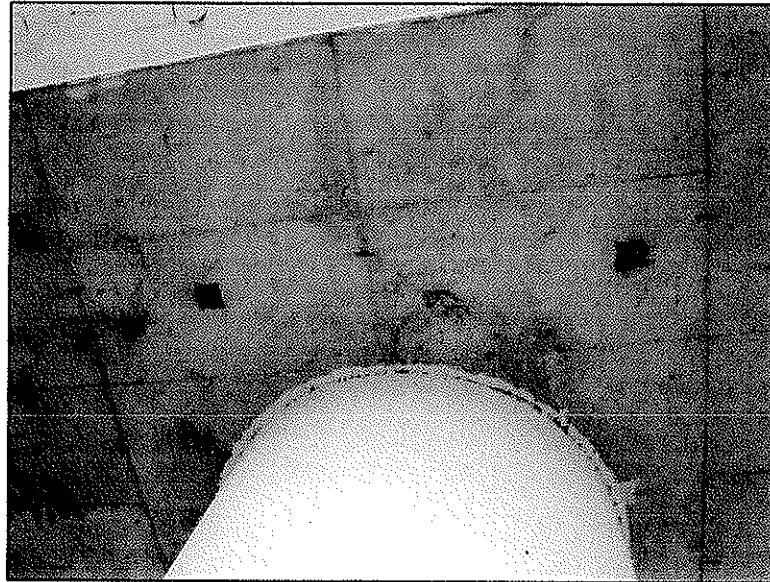
Figure 4.3.2-B (Mexico)

The bottom of the exterior cast-in-place overhang strip on the upstream side of bent cap 4 appears to have very little or no concrete cover. The bottom of bent cap 2 at the downstream side corner adjacent to span 1 is cracked and shows evidence of delamination as shown in Figure 4.3.2-A. On the Mexican side of the bridge, some of the bent caps have small patches on the bottom where it appears repairs were made. Also on the Mexican side, bent cap 2 has hardware embedded and left in place at the bottom of the cap from what appears to be epoxy injection repairs. Figure 4.3.2-B shows three locations of exposed rebar at the bottom of one of the bent caps on the Mexican side of the bridge.
